First Congregational Church

Essex Junction, VT

A Window Report

Sally Fishburn

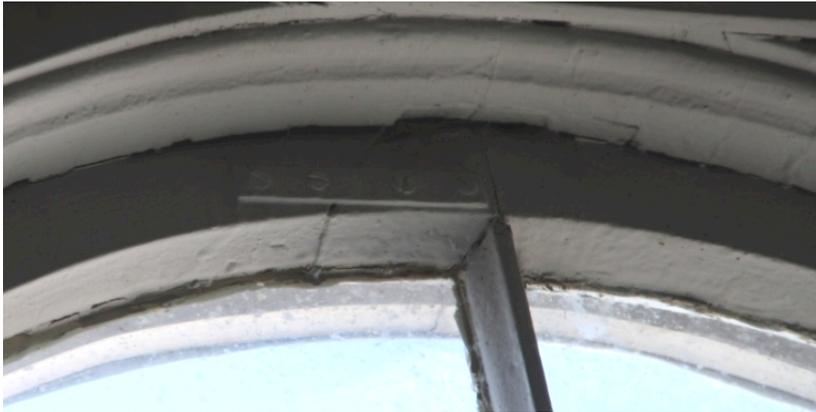
Overall the windows are in fairly good condition. There were no indications of deterioration in the sashes. A metal strap was noted securing a break in the wood at the top of a sash in the sanctuary. The wood in the semi-circular top rail often ends up with a short grain section. It is at this point that the wood cracked and the

strap was added to hold the sash together. This is a common fix. Otherwise there is no obvious structural damage to the sashes.

The sashes should be completely stripped, repaired as necessary, re-glazed and re-hung in the frames with the inclusion of weather stripping. S.A. Fishburn, Inc.'s restoration specifications are included at the end of this report providing a detailed description of the window restoration process.

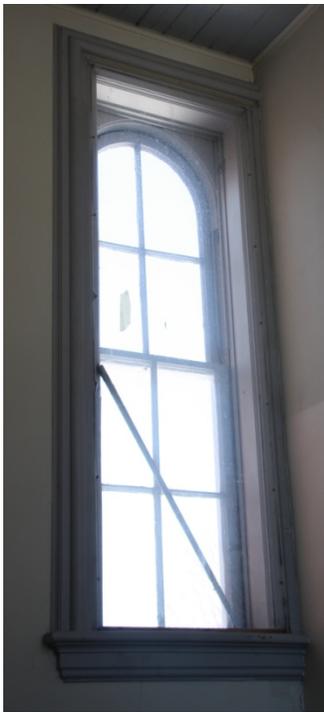
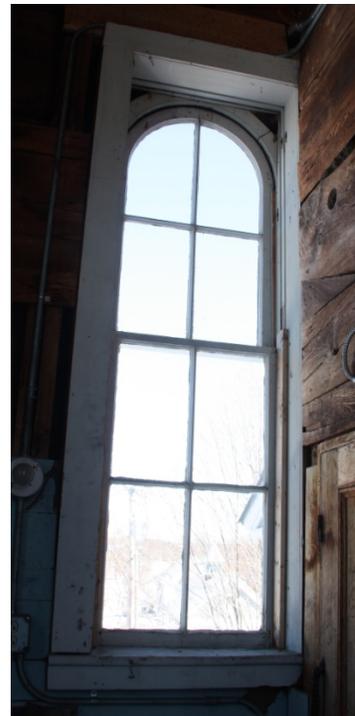
The sashes on the south side of the building show more deterioration in the exterior finishes, paint and glazing than the north side. This is normal given the south side's increased exposure to the sun. The top sashes are painted in place. It is assumed that they are attached to counter weights. The bottom sashes do open and those that were observed were functional with sound ropes attached to the weight and pulley counterbalance system. One top sash has dropped leaving a 1/2" gap between the top of the sash and the frame.

The windows located inside the bell tower were left unfinished on the interior. The bell tower is an unfinished, unheated space so there was no reason to spend extra expense to trim these windows. These windows do include the tracks and hardware for the sliding blinds although there is no indication that blinds were ever installed. This is clear evidence that the original windows were built to include the sliding blinds.

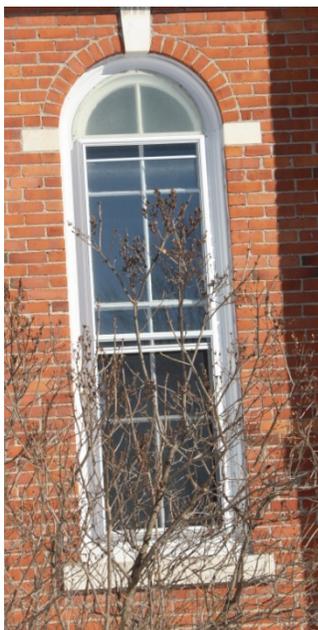
With the exception of the sills, the frames appear to be in sound condition. All of the window sills in the sanctuary have been covered with sheet metal. Either the sheet metal was installed as a lead paint remediation measure or they are a quick fix to cover deteriorated sills. It is more likely that they are covering deteriorated sills.

The assumption is that removing the sheet metal will reveal heavy weather checks and/or sills with rotten sections.

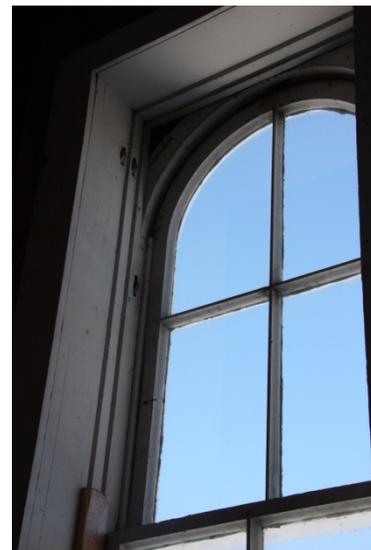
On the unfinished bell tower frames it appears that the side jambs were built of one wide piece of stock with four tracks, two for the sashes and two for the blinds, with parting beads separating the four tracks plus the interior stops. In the aftermarket variety the tracks for the blinds replace the interior

stops.

The sliding blinds should be considered part of the window unit and should be restored along with the sashes following similar specifications. The blinds appear to be in sound structural condition with cosmetic damage that can be repaired during restoration if desired.

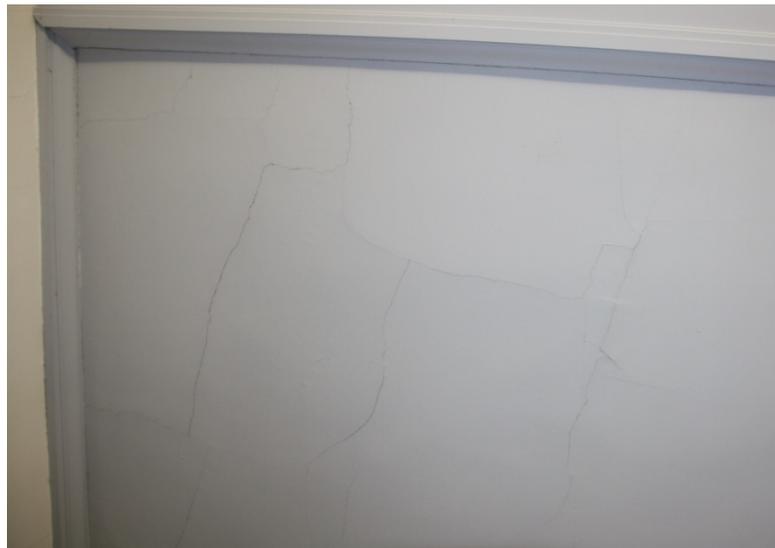
The sanctuary, vestibule, and choir loft retain the original plaster and lathe. The plaster system and composition may vary between the original building and the 1913 additions. Although the plaster has cracked in many areas it is still predominantly tight to the lathe and

structurally sound.

Dark cracks, which often run diagonally, are the result of movement or settlement creating stress in the building. Dark cracks have developed in areas around the church with the highest concentration and most severe cracks around the bell tower. This is understandable given the 1913 construction work. Generally the area of plaster adjacent to cracks has delaminated from the lath. In order to effectively repair the cracks for the long term the lath should be reattached to the plaster prior to filling the voids left by the cracks. This is achieved through plaster re-adhesion. During the repair of the cracks any other areas of delamination found should also be re-adhered.

In all areas where the plaster has separated from the lath it will be re-adhered to the lath with acrylic adhesives. 3/16" holes are drilled through the face of the plaster to provide injection ports for the adhesives. The holes are vacuumed out, a pre-wet solution sprayed in to the hole and then the adhesives are injected through the hole into the space between the lath and plaster. Large square washers are screwed through the plaster into the lath to pull the plaster tight to the lath while the adhesives cure. Once the adhesives have cured, generally overnight, the washers are removed and the holes and cracks are filled with an appropriate plaster patching material. The voids are filled flush with the surface. The original plaster surface is left intact.
