First Congregational Church

Essex Junction, VT

A Window Report

Sally Fishburn

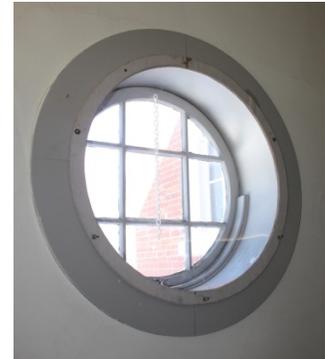
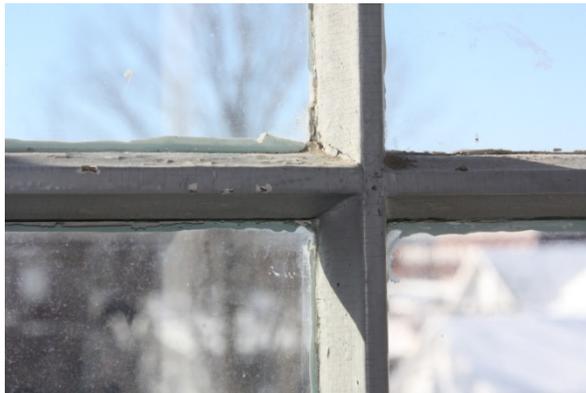
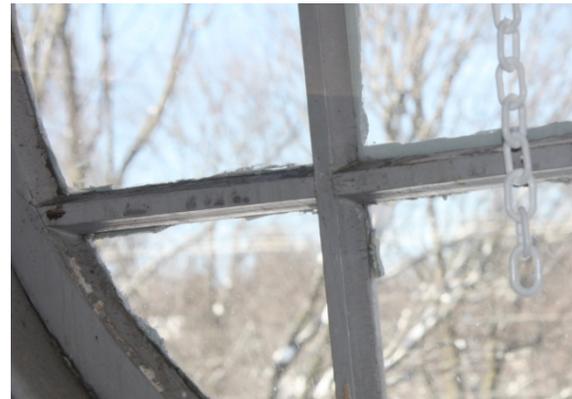
In the early photo there are six of the large window units on the sides and two on the front elevation, one to each side of the bell tower. It is presumed that the two front units were moved to the extension at the back of the building creating the four windows per side on the 1913 version of the church. The two slightly smaller windows on the sides of the original entry door were moved into the new vestibule. There are four window units in the vestibule. Given that the four units are identical there is good reason to postulate that the third and fourth units in the vestibule were moved from the back of the church. However there is no documentation to prove this.

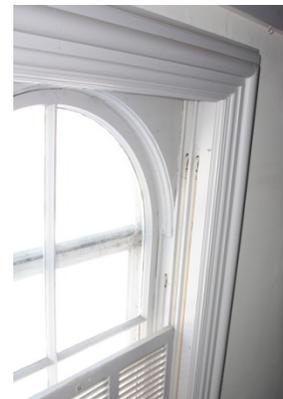
The circular windows have wide, flat interior casings. The only other windows that have a flat casing are the two in the areas flanking the choir loft behind the sanctuary. Given that they are located in circulation areas the simple casings are logical. All of the other windows have a decorative casing created by adding trim to the flat casings. The interior edge is dressed up with an astragal and a larger torus located in the middle of the flat face of the casing.
